# Test Report

<b>Sample Name</b>	: Architectural Flexible Linear Lighting
<b>Sample Model</b>	: FlexWash-06_3525-48, NeonLine-01_2020-15
<b>Inspection Classification</b>	: Commission test
<b>Manufacturer</b>	: Shanghai Jingtou Intelligent Technology Co., Ltd.
<b>Client</b>	: Shanghai Jingtou Intelligent Technology Co., Ltd.

## Test Item: High and low temperature cycle

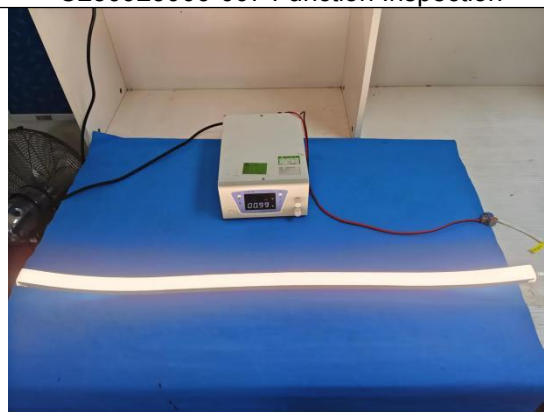
C250923006-008 Function Inspection

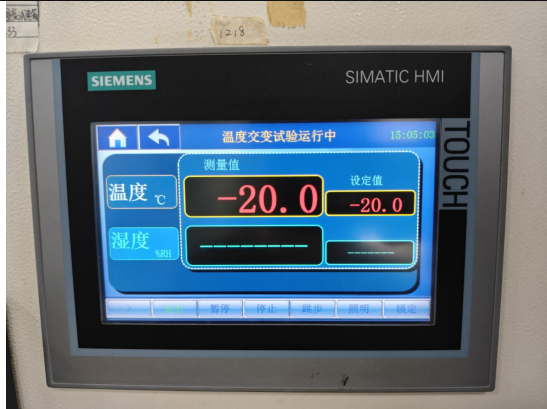
Temperature interface1

1. High temperature: 85 ℃;
2. Low temperature: -20 ℃;
3. High temperature holding time: 30 minutes;
4. Low temperature holding time: 30 minutes;
5. Test cycle: 168 times.
6. Judgment requirements: After the test, there were no obvious abnormalities in appearance and the function was normal

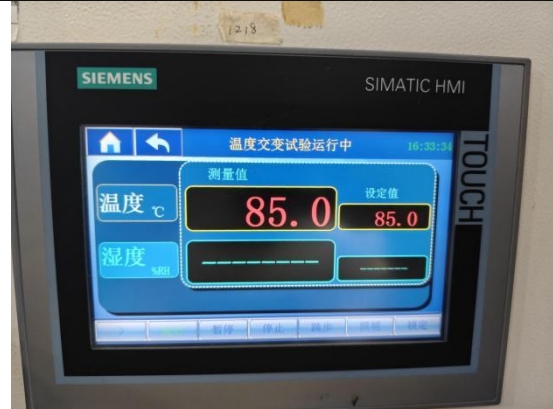
Temperature interface2

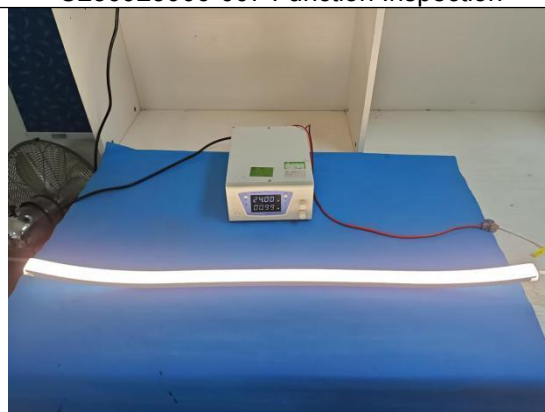
C250923006-008 Function Inspection

Sample No.	Test Result	Judgment
C250923006-007~008	After the test, there were no obvious abnormalities in appearance and the function was normal	PASS
